Seismic-reflection surveys at sinkholes in central Kansas

by *Ralph W. Knapp, Don W. Steeples, Richard D. Miller, and Carl D. McElwee*
Kansas Geological Survey, Lawrence, Kansas 66046

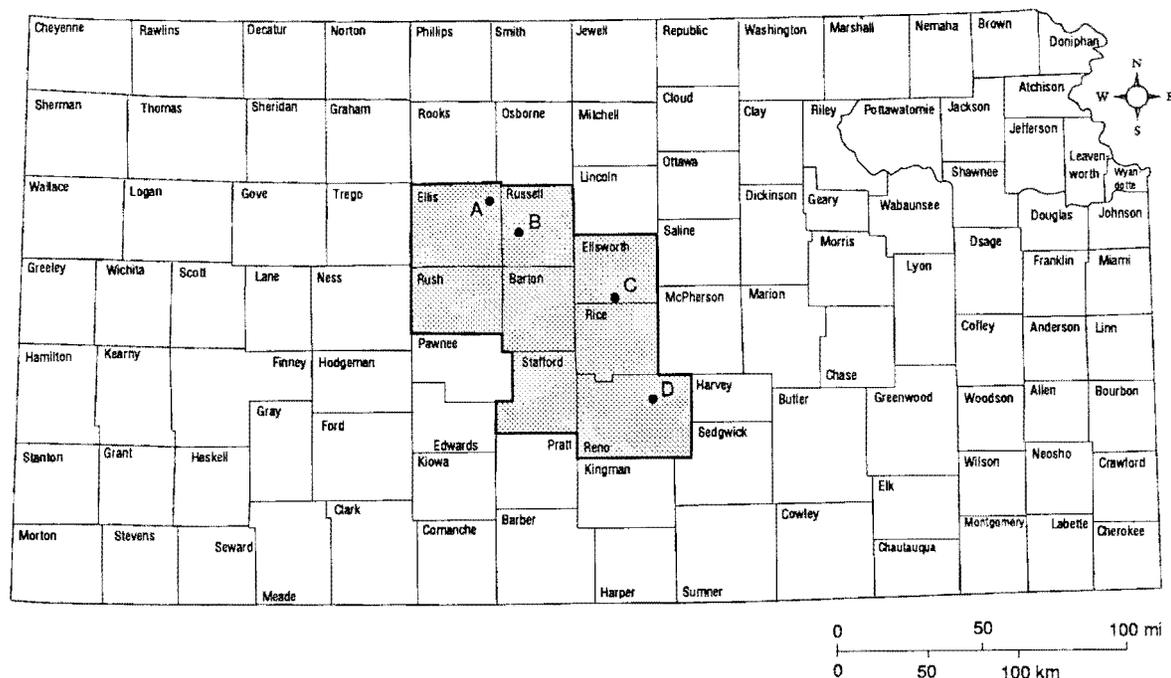
FIGURE 1—MAP OF KANSAS SHOWING LOCATIONS OF THE A) Nielsen sink (Ellis County), B) I-70 sinks (Russell County), C) Janssen sink (Ellsworth County), and D) Punkin Center sink (Reno County).

Since 1979 the Kansas Geological Survey has conducted high-resolution seismic-reflection surveys over several known salt-dissolution sinkholes in central Kansas. The sites are located in fig. 1 and are identified as the Nielsen sink (Ellis County), the I-70 sinks (Russell County), the Janssen sink (Ellsworth County), and the Punkin Center sink (Reno County). Because each site has unique features, they will be discussed separately.

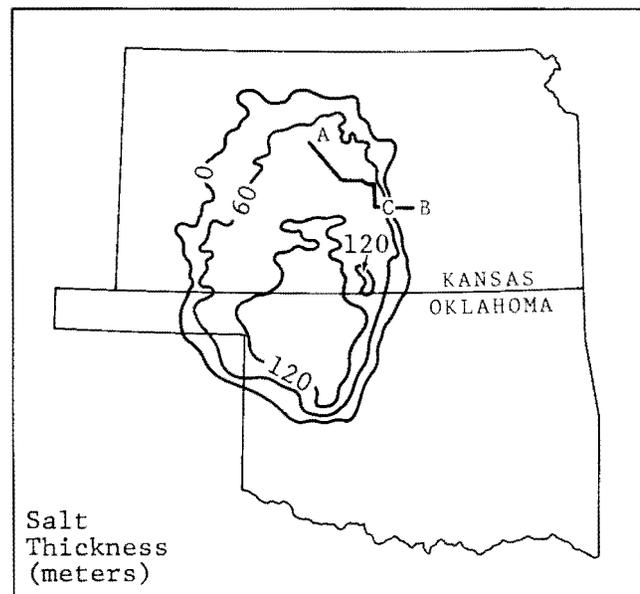
FIGURE 2—GENERALIZED EXTENT AND THICKNESS OF HUTCHINSON SALT MEMBER OF THE PERMIAN WELLINGTON FORMATION. LOCATION OF CROSS SECTION IS SHOWN FOR FIG. 3. THE NIELSEN SINKHOLE IS LOCATED AT A. THE I-70 SINKHOLES ARE LOCATED AT B. THE PUNKIN CENTER SINKHOLE IS NEAR D, AND THE JANSSEN SINKHOLE IS NEAR C; MODIFIED FROM WALTERS (1977).

As can be noted at location "D" of figs. 2 and 3, the Reno County site is in a similar geologic situation as the previously described sites, except that the salt is shallower and the Stone Corral is missing. At this site the salt is between 15 m and 60 m (50–200 ft) thick at a depth of 120 m to 200 m (400–660 ft). Examination of drillers logs at nearby wells indicates a high degree of variability in the occurrence of the evaporite sequence. Since the salt-dissolution front (fig. 3) subcrops just a few kilometers to the east of the site, the variation is not surprising.

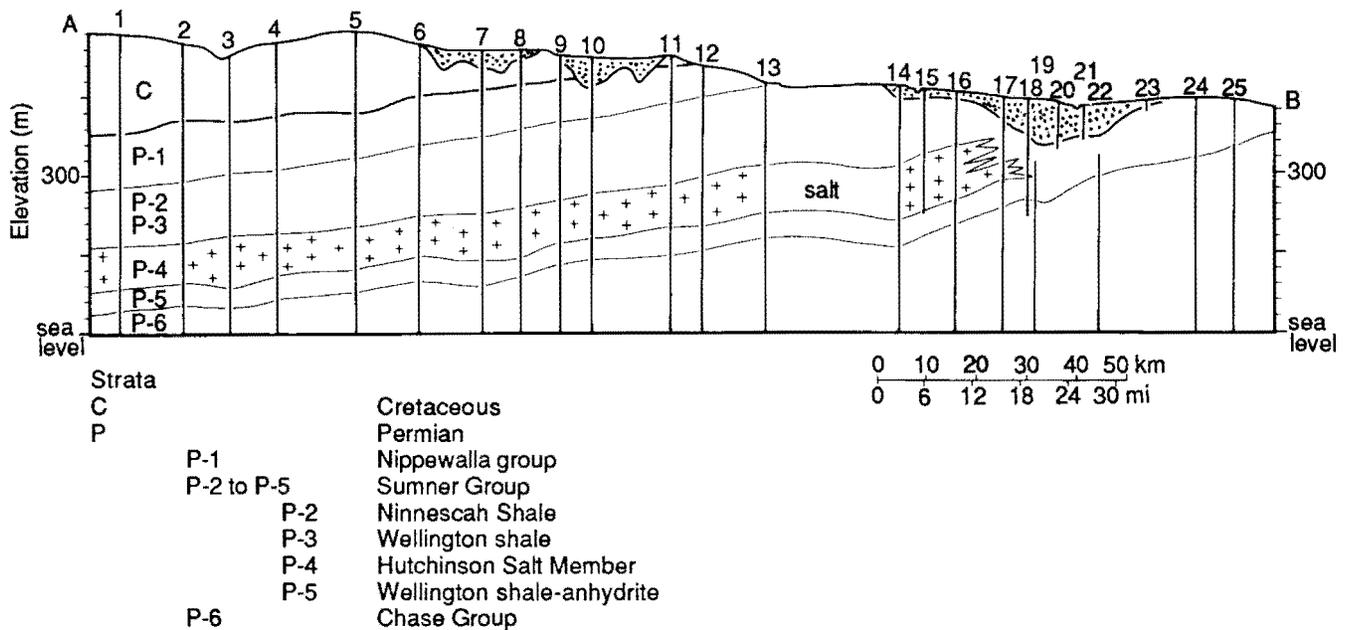
FIGURE 3—CROSS SECTION OF FIG. 2. Rock-unit names below the figure correspond to the labels on the figure. Location of wells drilled for oil, gas, and water are depicted by numbers along the top of the cross section; modified from Walters (1977), where the well locations are listed and discussed.

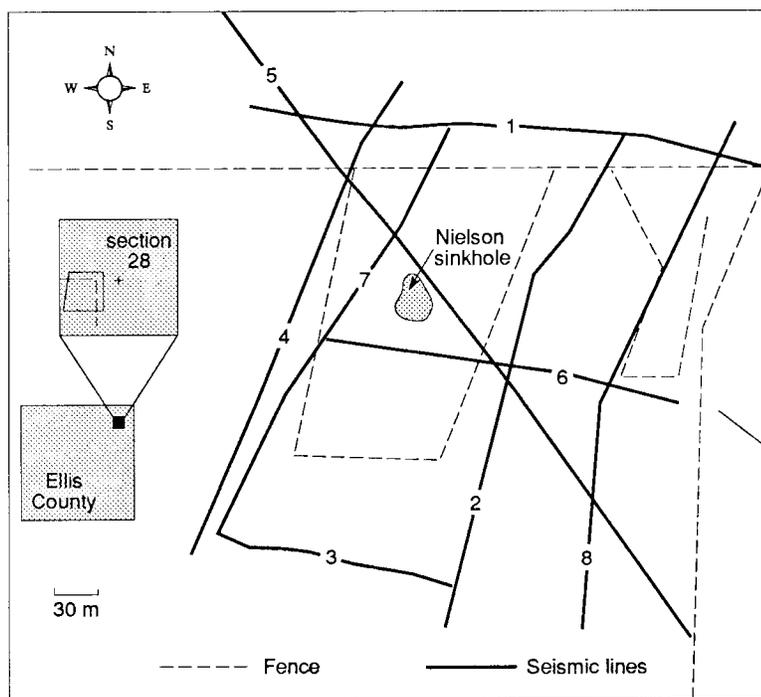
FIGURE 4—PROFILE-LOCATION MAP FOR NIELSON SINKHOLE IN ELLIS COUNTY.

Seismic-reflection profiles run at Nielsen sink are shown in fig. 4. The original intent was to run a profile all the

way around the sink outside the fence and to run three intersecting profiles inside the fence. It was thought that the profiles outside the perimeter of the fence would establish the presence or absence of natural faulting in the area. The profiles inside the fence would be used to detail the fine structures within the sink area to depths of 500–600 m (1,600–2,000 ft). Examination of records in the field indicated that the north-south profile outside the fence east of the sinkhole (profile 3) passed above one or more faults. To establish the presence or absence of the faults, another north-south profile (profile 8) was run across the draw east of the sinkhole. In retrospect it is clear that we have not yet run seismic profiles south and east of the sink that are unaffected by the subsurface presence of the sinkhole.

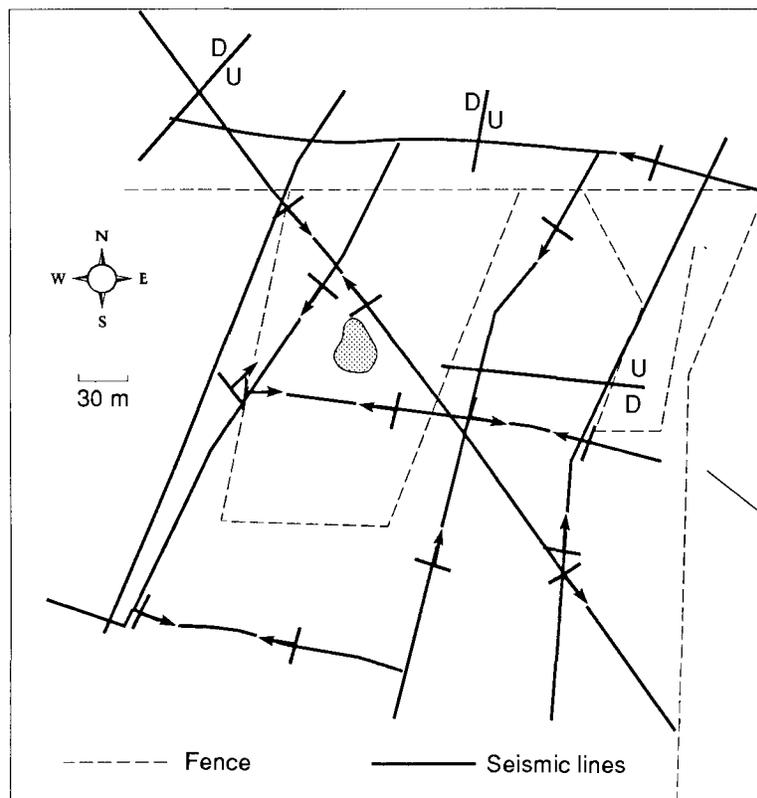
FIGURE 5—FAULTS AND FLEXURES. Faults are mapped where found on the profiles. Unfortunately, they neither tie together well nor have an obvious trend. Faulting is not identified on the profiles as dim-outs of reflection without associated offset. Dimmings are due to tensile fracturing of the rock and are identified as flexures. The associated directions of sag are plotted. Flexures appear to be due to salt dissolution.

The geologic interpretation that has evolved at the Nielsen sink shows a very complex tangle of faults. Fig. 5 shows the locations of the faults and flexures that affect the Stone Corral. The interpretation is subject to considerable uncertainty because of poor data quality in some of the area around the sinkhole.

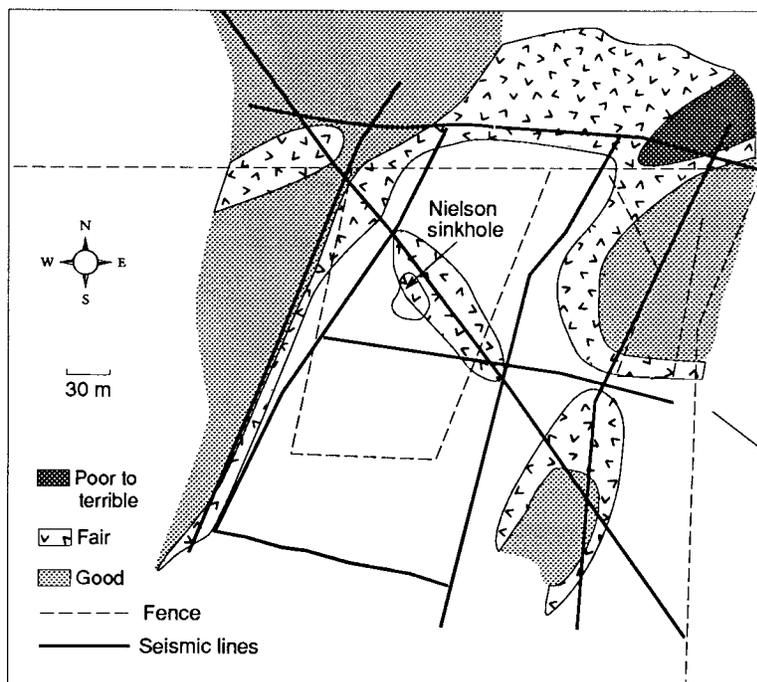
FIGURE 6—REFLECTION QUALITY OF THE STONE CORRAL. Poor quality is dark; good quality is light; average is left blank. In general, poor-quality reflections correlate with dissolution of the evaporites, or with formation of rubble zones.

Fig. 6 shows the interpreted relative data quality along the profiles. It is interesting that data quality is poorest on the flanks of the sink rather than in the middle of the sink. The thinness of the underlying salt is depicted qualitatively in fig. 7. In general, the areas of good data quality shown by fig. 6 correspond to areas of structurally high Stone Corral and thick salt. That observation is scientifically reasonable in that disturbance from normal position of the Stone Corral also tends to degrade the reflection quality of the I-70 profiles. Poor data quality and salt thinning are both skewed to the south and east of the center of the sink. There is a suggestion that they follow the trend of the easternmost north-south-running fault of fig. 5.

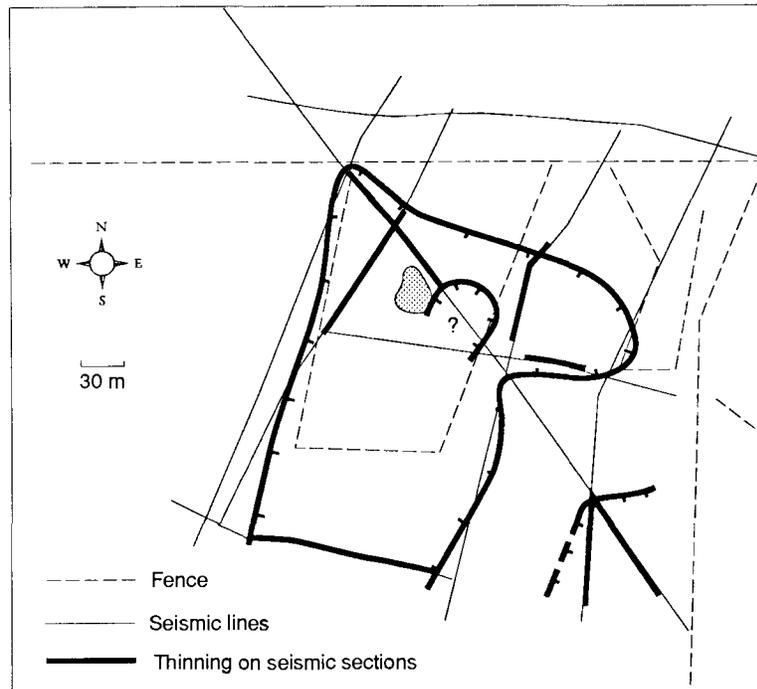
FIGURE 7—SALT THINNING. Extent of salt dissolution (shaded area) as interpreted by identification of top and bottom of salt, and sagging of the Stone Corral. Profile 6 is ambiguous due to poor reflection quality; it is suspected that the salt is missing under most of the profile.

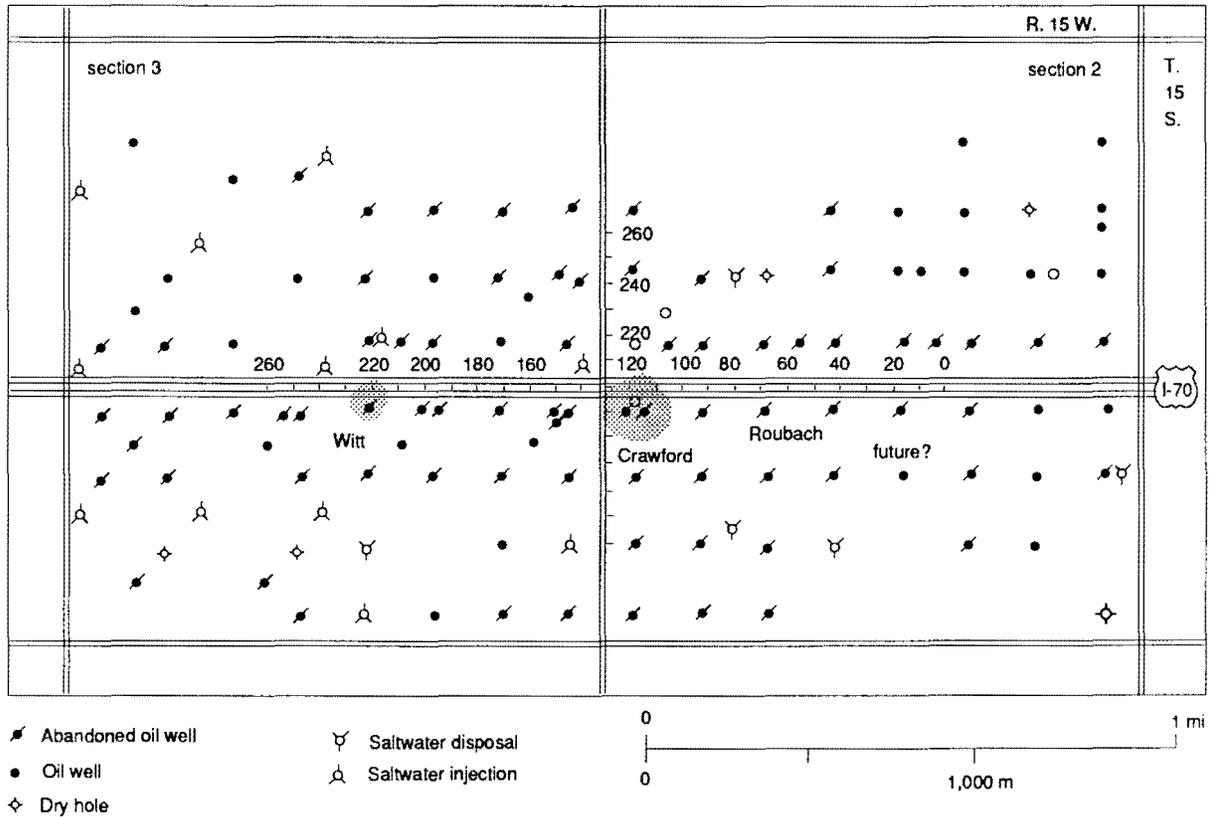
FIGURE 8—MAP OF I-70 SINKHOLES IN RUSSELL COUNTY.

Three sinks are documented in the vicinity of the I-70 profiles (fig. 8). From west to east they are the Witt, the Crawford, and the Rouback sinks.

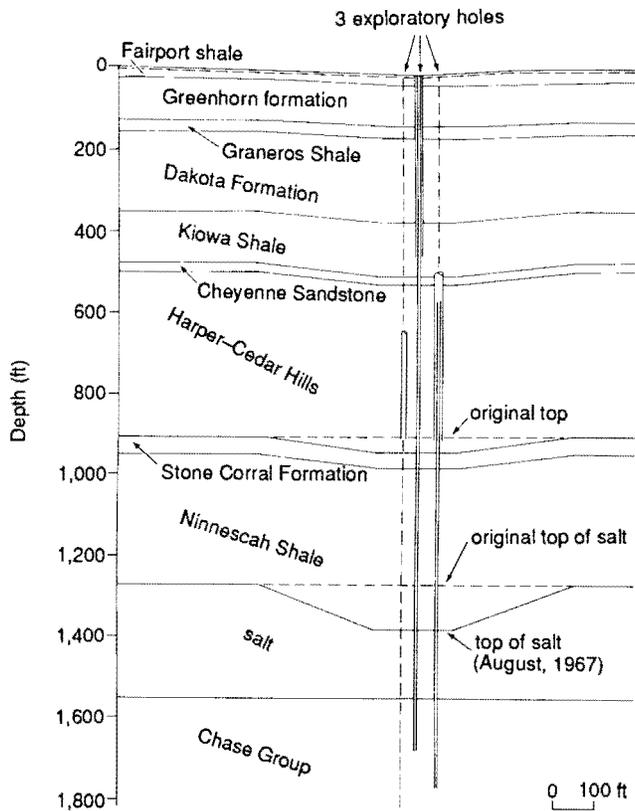
FIGURE 9—CROSS SECTION OF CRAWFORD SINK (I-70) FROM KANSAS DEPARTMENT OF TRANSPORTATION, BASED ON DRILLING AND LOGGING IN 1967.

The Crawford sinkhole on I-70 was drilled and geophysically logged by the Kansas Department of Transportation in 1967, and the results are summarized in fig. 9. Note that at the time the tops of the Stone Corral and the Hutchinson salt were about 12 and 35 m (40 and 116 ft) below normal elevation, respectively. Seismic-reflection data indicate that the Stone Corral in particular has dropped almost 30 m (100 ft) since 1967. Conclusions that can be drawn from the I-70 seismic profile will be discussed from west to east.

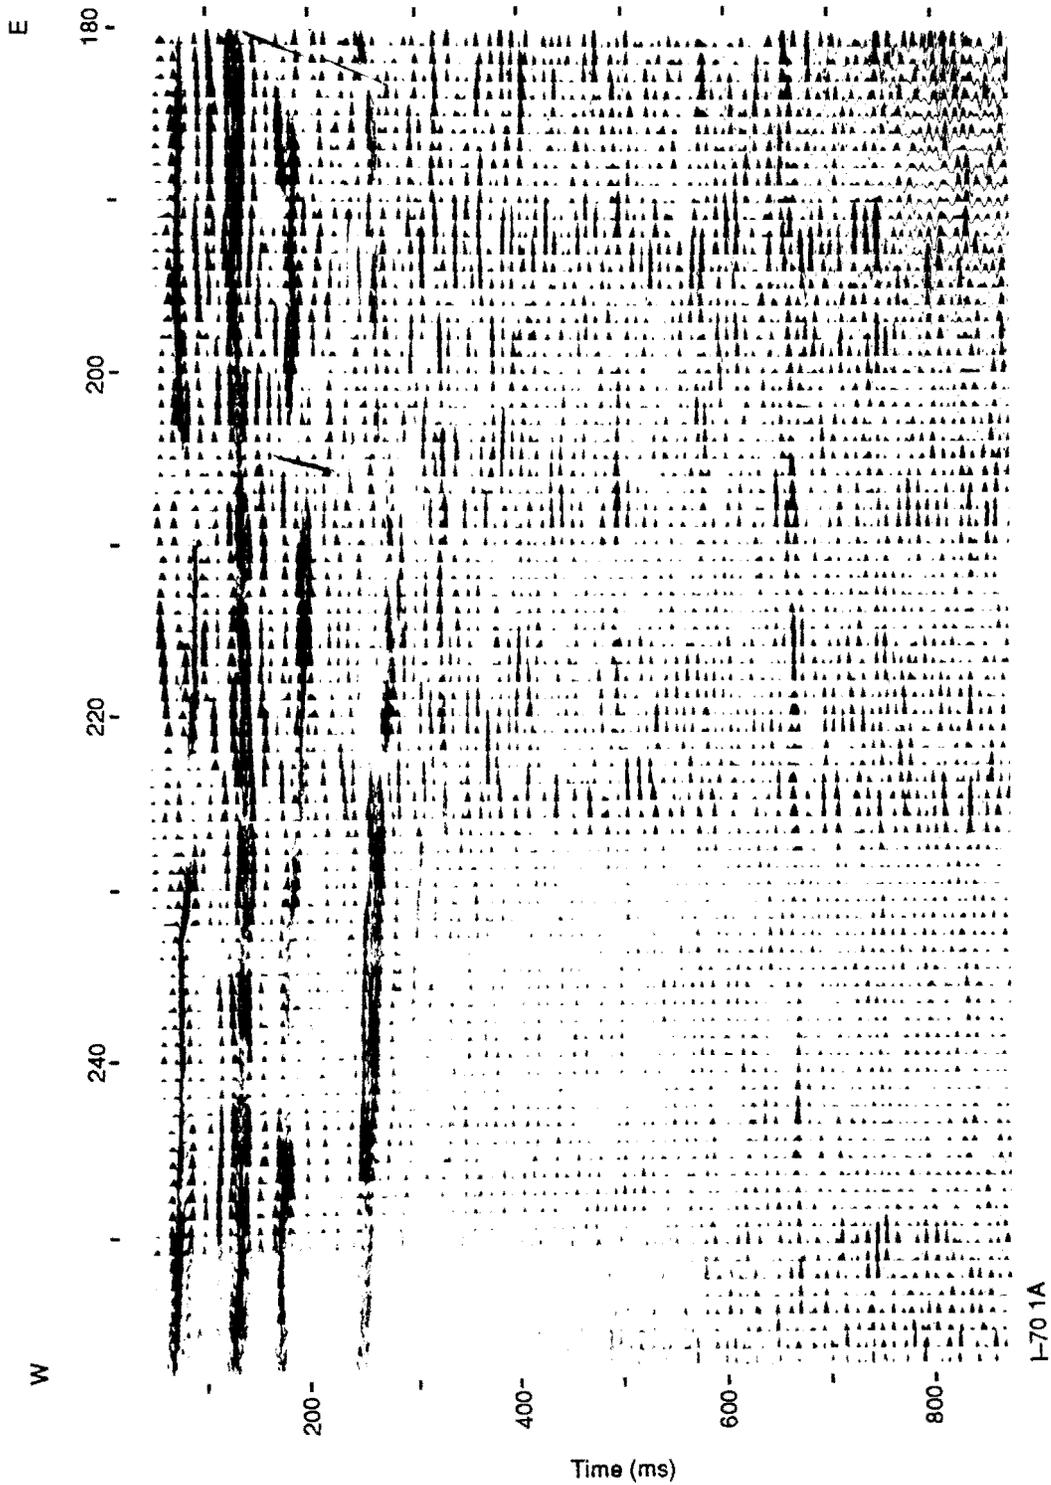
FIGURE 10—SEISMIC-REFLECTION RECORD SECTIONS FOR WEST-EAST PROFILE ALONG I-70 THAT CROSSES WITT SINK. Common depth points are 8 m (26 ft) apart. Figs. 11 and 12 are labeled in identical fashion.

The Witt sink (fig. 10) shows on the seismic profile between CDP 206 and CDP 222 with the Stone Corral down-dropped about 15 m (50 ft; 10-msec two-way travel time) along its west side (near CDP 223). The area to the west of

Witt sink is interpreted to have competent rock at all depths to well below the salt. At the center of the sink (near CDP 215), the Stone Corral is either downdropped about 40 m (130 ft) or its upper surface has been broken up or partially dissolved. Stone Corral reflections exhibit incoherent or broken-up characteristics for about 400 m (1,300 ft) eastward from the center of Witt sink. The area east of Witt sink for about 400 m (1,300 ft) may subside in the future.

Between the Witt and Crawford sinks (figs. 10 and 11), a zone of competent Stone Corral begins about 300 m (990 ft) west of the Crawford sink overpass and continues eastward from CDP 166 for about 240 m (800 ft) to CDP 134 about 60 m (200 ft) west of the I-70 overpass. This 240-m (800-ft)-long zone would not be expected to subside.

These CDP numbers exactly correlate with those in fig. 10. On both the dynamite data and the Mini-SOSIE data in this area, the first positive peak is either subdued or missing, suggesting that the upper few meters of Stone Corral have either been dissolved or intensely fractured. This phenomenon is also noted at Nielsen sink in Ellis County.

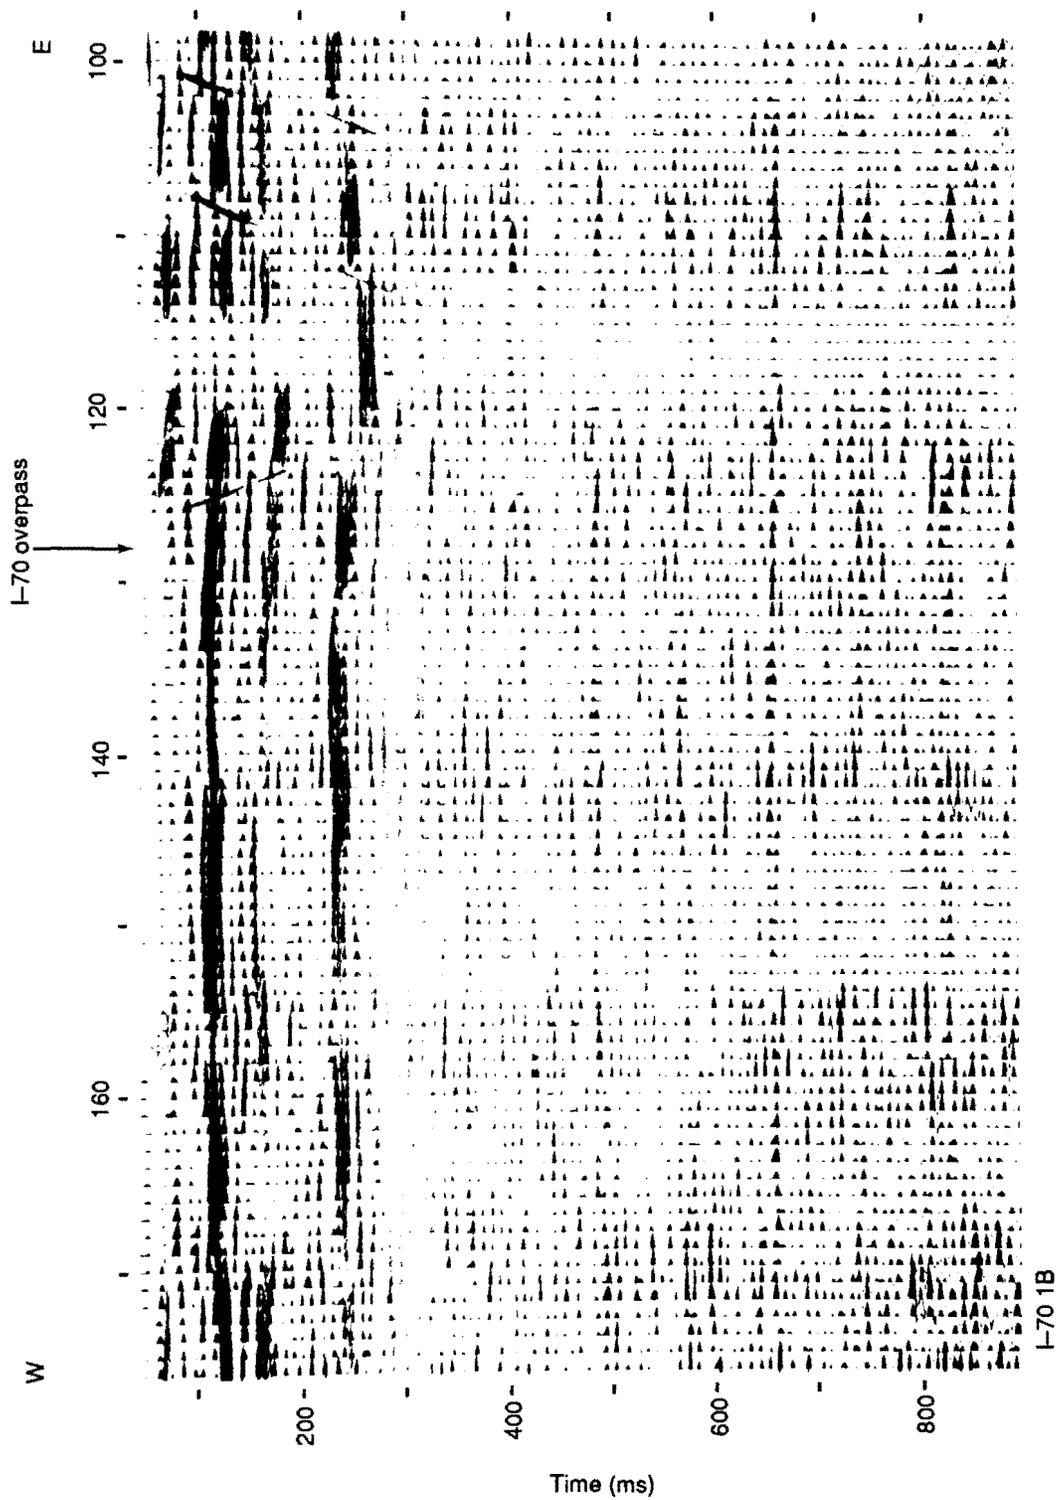
FIGURE 11—SEISMIC-REFLECTION RECORD SECTION FOR WEST-EAST PROFILE ALONG I-70 THAT TRAVERSES AREA BETWEEN WITT SINK AND CRAWFORD SINK. The downdropped Stone Corral in the Crawford sink is clearly visible at times of 200 to 300 msec between CDPs 100 and 130.

The Crawford sink (fig. 11) begins in the subsurface at CDP 131, about 60 m (200 ft) west of the overpass, and extends to near CDP 98, about 260 m (850 ft) east of the overpass—its total east-west extent along I-70 slightly exceeds 300 m (1,000 ft). The sink is marked at depth by at least five faults (four shown; one fault is just off the east edge of

fig. 11) in the Stone Corral, which is downdropped in graben-like fashion into the central area of the sinkhole. The total vertical movement of the Stone Corral has been about 45 m (150 ft; 30-msec two-way travel time) at the deepest part of the sinkhole along I-70. The center of the sink is south of the highway; hence, it is not possible to evaluate conditions at the center of the sink from our traverse on the north rim of the sinkhole.

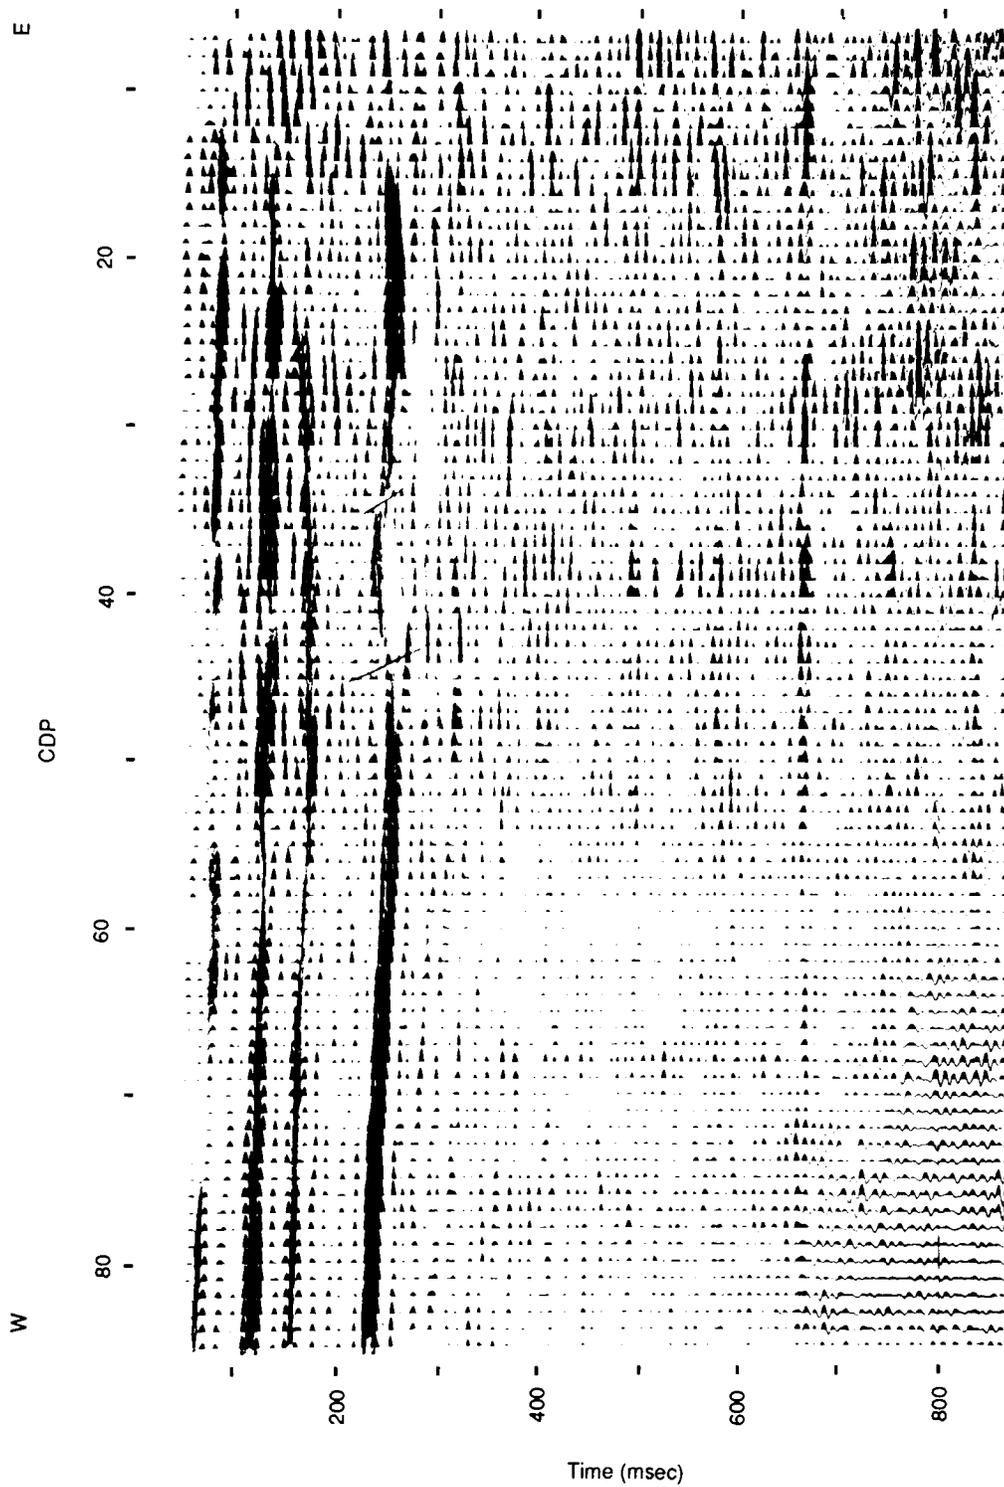
FIGURE 12—SEISMIC- REFLECTION RECORD SECTION FOR WEST-EAST PROFILE ALONG I-70 THAT TRAVERSES ROUBACK SINK AND POSSIBLE INCIPENT SINK.

The Rouback sink (fig. 12) begins in the subsurface near CDP 43, about 670 m (2,200 ft) east of the overpass, and continues to near CDP 43, about 670 m (2,200 ft) east of the overpass. The eastern edge of the Rouback sink is faulted at the Stone Corral, while the west side of the Rouback is an eastward-dipping monocline. Total vertical displacement on the Stone Corral is about 30 m (100 ft; 20-msec two-way travel time).

The Stone Corral is at its normal depth from near CDP 41, about 670 m (2,200 ft) east of the overpass, to near CDP 35, about 750 m (2,500 ft) east of the overpass. At 750 m (2,500 ft) east of the overpass, near CDP 35 (fig. 12), the

Stone Corral appears to be downdropped to the east by about 20 m (70 ft; 14-msec two-way travel time). This indicates possible development of a new sink at the eastern edge of our seismic profile. Our data end about 1.0 km (0.6 mi) east of the 1-70 overpass. It is not known what relief, if any, is present on the Stone Corral eastward beyond that point. It is suspected that subsidence will occur if it has not already occurred in an area from 760 m (2,500 ft) east of the overpass to at least 900 m (3,000 ft) east of the overpass.

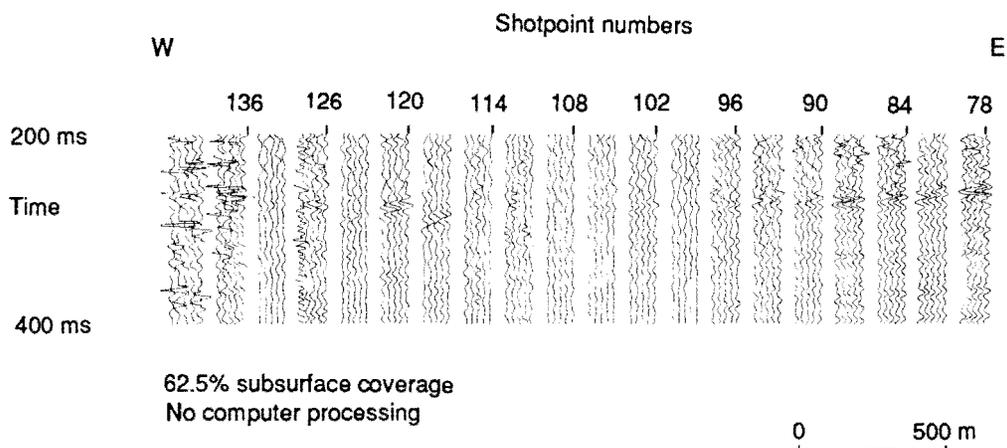
FIGURE 13—DYNAMITE SEISMIC-REFLECTION DATA FROM MAY 1979. The Stone Corral reflector is visible at a time of about 260 msec in the eastern one-third of the profile. The CDP numbers on this figure correspond to figs. 10–12; the CDP numbers can be obtained by multiplying the shotpoint numbers by 2.

- a) The Witt sink has an area on its east side that is disturbed in the subsurface for a distance of at least 360 m (1,200 ft). This zone shows differences in seismic-wavelet character for the Stone Corral reflection. This can best be seen on 62.5%-fold dynamite data (fig. 13) between CDP 179 and CDP 195.

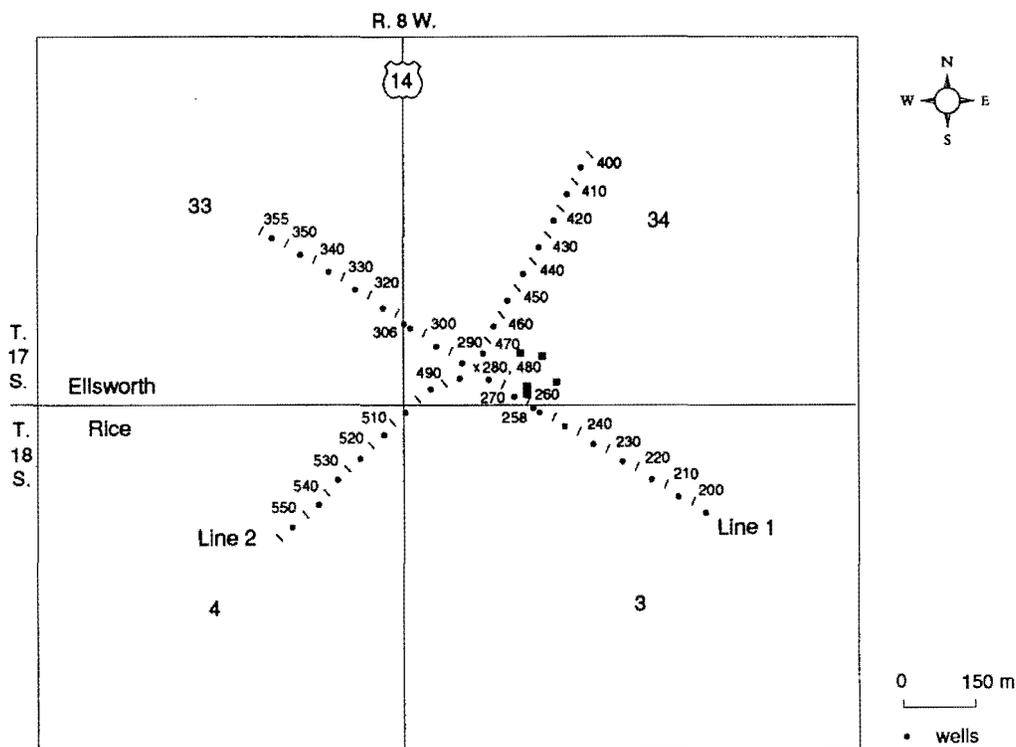
FIGURE 14—CDP-NUMBER LOCATION MAP OF JANSSEN SINK SEISMIC LINES IN ELLSWORTH COUNTY. CDP interval is 5 m (17 ft).

The Janssen sink is located in southern Ellsworth County about 13 mi (21 km) north of Lyons on K-14, about 3 mi (5 km) west of Geneseo (fig. 14). Noticeable subsidence has been occurring about the Janssen "B" #6 well, which was a production well in the Genesco-Edwards oil field converted to saltwater disposal. About 3 m (10 ft) of subsidence has occurred and is occurring at a rate of about .5 m (1.6 ft)/yr.

Profile 1 traverses the sinkhole from southeast to northwest intersecting the county road at CDP 258 and K-14 at CDP 306 (fig. 14). The surface expression of the sinkhole extends from CDP 270 to CDP 295 on profile 1 (fig. 15). Modeling by Neely (1985) shows the Stone Corral to be the strongest reflector in the section (fig. 16). It is at about 140 msec at the flanks of the section. The top of the Hutchinson salt is at about 220 msec and its bottom at about 240 msec.

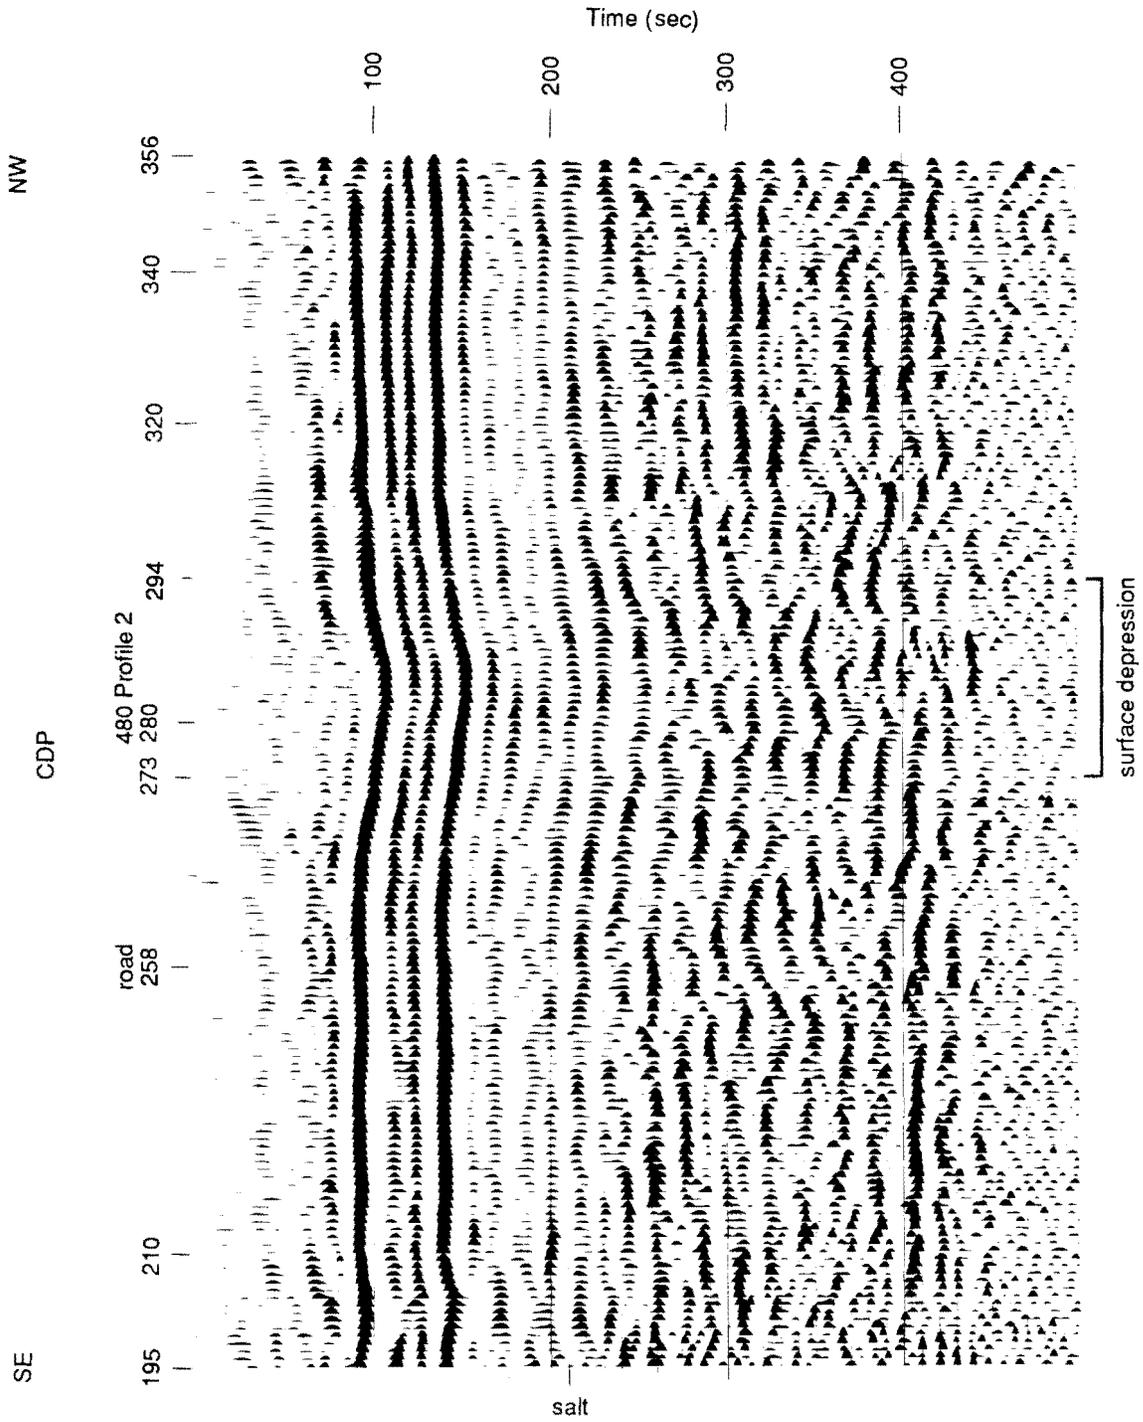
FIGURE 15—SEISMIC SECTION OF PROFILE 1 WHICH QUITE CLEARLY SHOWS THE SUBSURFACE EXTENT OF THE DISSOLVED SALT LAYER AT ABOUT 140 MSEC.

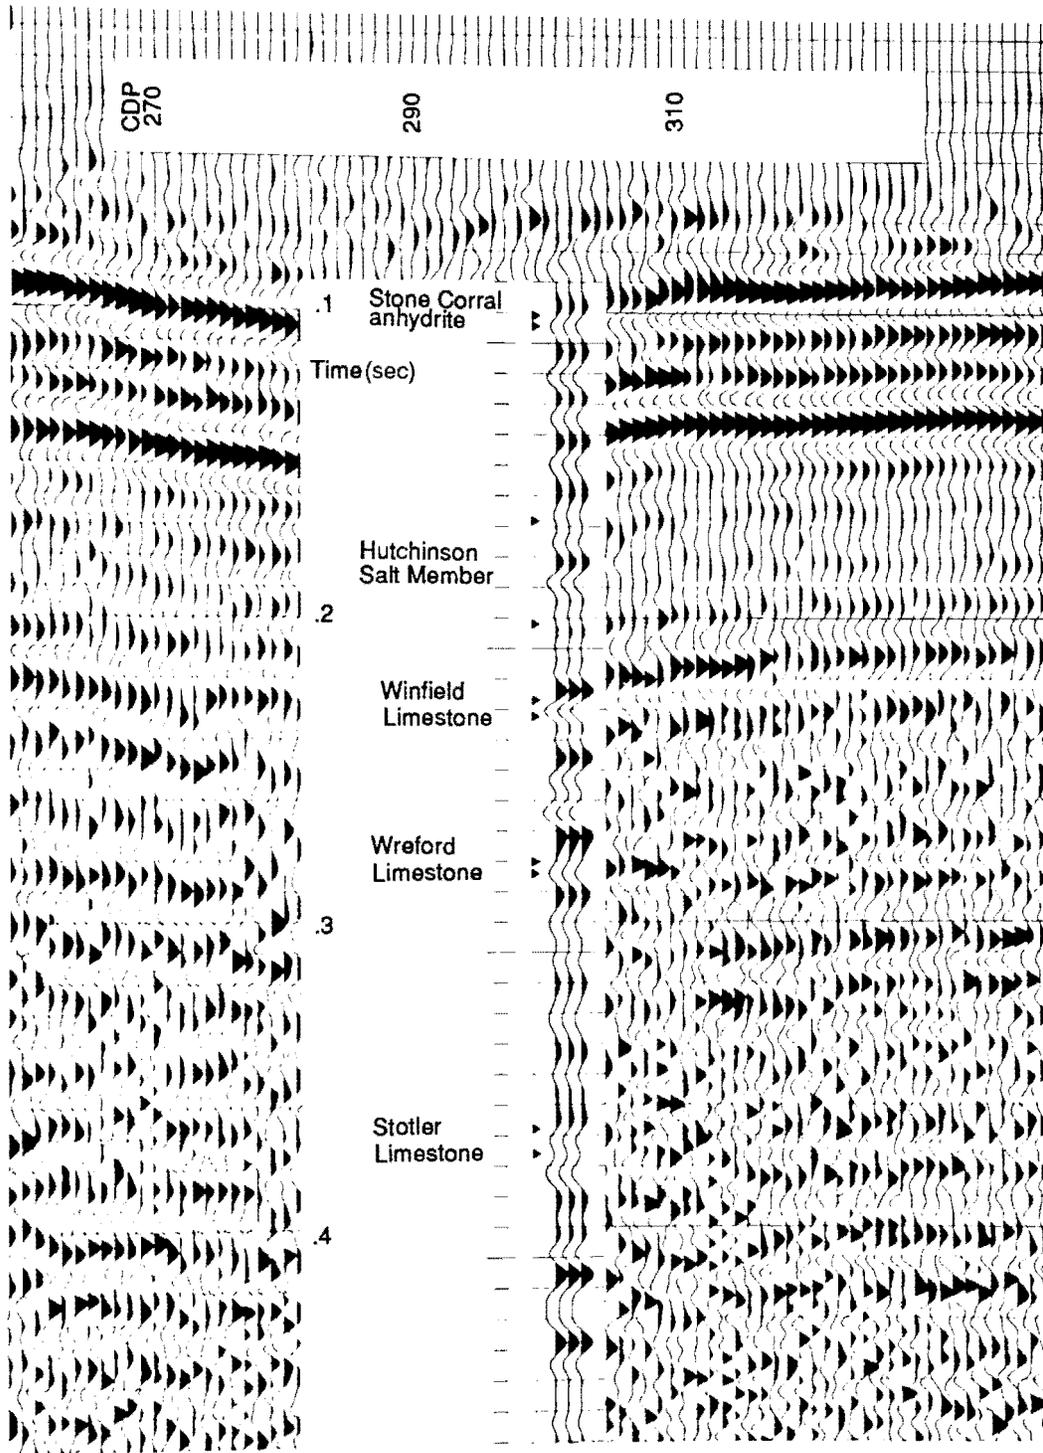
FIGURE 16—COMPARISON OF SEISMIC AND SYNTHETIC DATA FOR PROFILE 1 OF THE JANSSEN SINK (Neely, 1985).

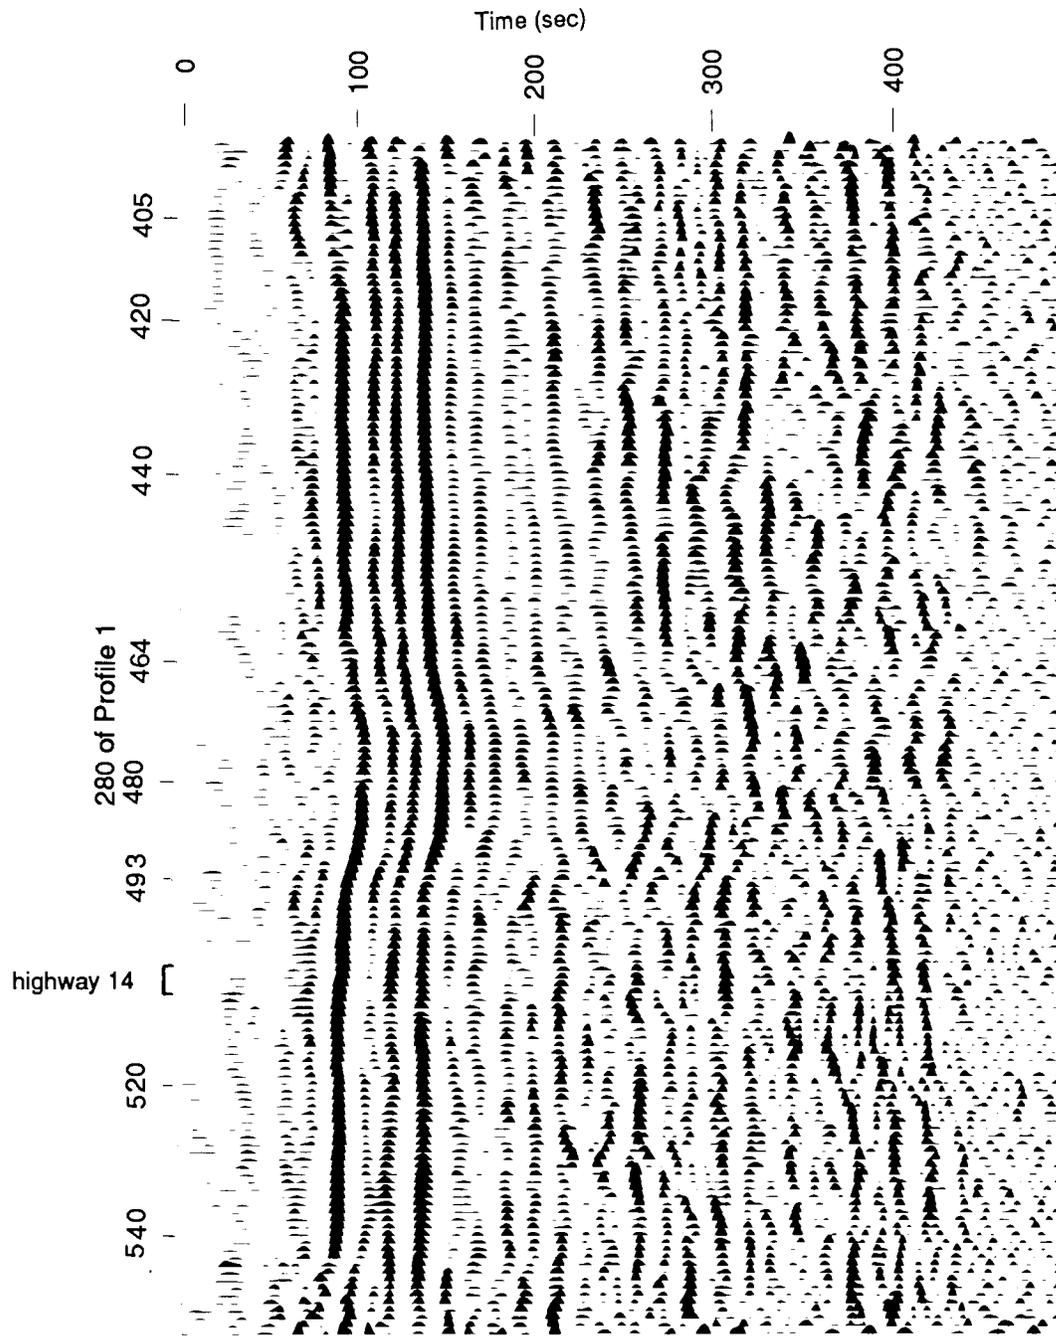
FIGURE 17—SEISMIC SECTION OF PROFILE 2 WHICH TIES TO PROFILE 1 AT CDP 480 EQUATING TO CDP 280 OF PROFILE 1. Here as in profile 1, the subsurface extent of the disturbed salt is quite clear. Poor data on the flanks of the sink are characteristic of reflection data over sinkholes.

Profile 2 (fig. 17) crosses the sink from northeast to southwest and crosses the county road and K-14 intersection

from CDP's 504 to 508. As in profile 1, very strong reflectors can be identified above 140 msec (Stone Corral) with poor data quality below that time. The character of the energy present on the seismic section of profile 2 is easily matched with that on profile 1. CDP 480 on profile 2 and CDP 280 on profile 1 represent the same subsurface point. Between CDP's 405 and 464 of profile 2 there seems to be a very steady gradational increase of about 6 msec in the arrival time of the wavelet identified previously as the salt in discussion of profile 1. Displacement of the salt reflector between CDP 464 and 491 appears to be about 9 msec. This would imply a total salt displacement of about 15 msec which would represent approximately 30 m (100 ft) of actual subsidence in the subsurface at the depth of the salt (velocity of the salt is about 4,000 m/sec or 13,000 ft/s). This agrees quite well with profile 1.

On the western boundary of the structural low formed in the salt from dissolution there exists a significant drop in reflector clarity of the disturbed area. This corresponds to CDP's 340 through 312 on profile 1 (fig. 15) and CDP's 493 and 503 on profile 2 (fig. 17). This drop in data

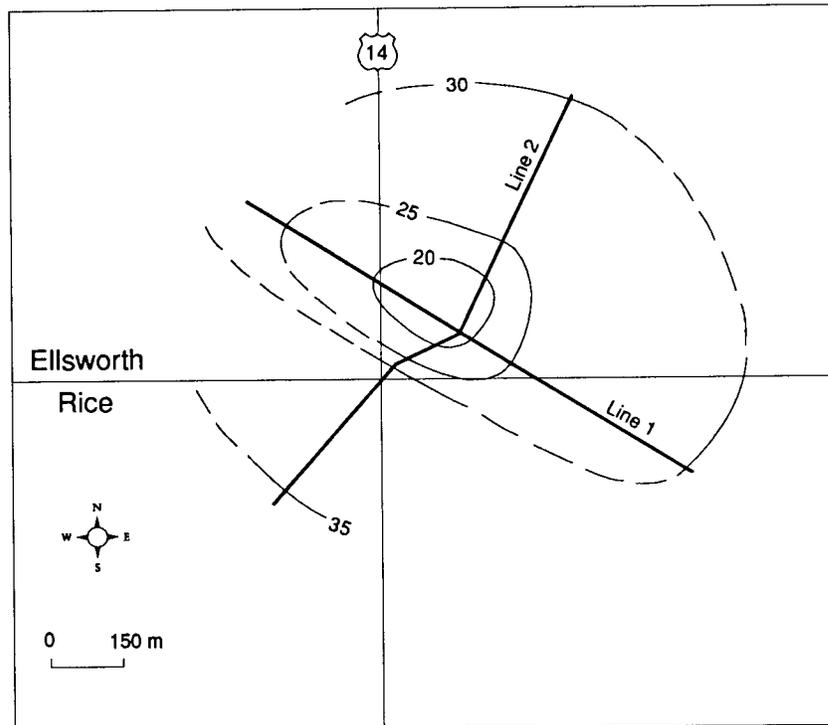
FIGURE 18—THE CONTOURS SHOW TIME THICKNESS, OR TWO-WAY TRAVEL TIME, OF THE HUTCHINSON SALT. THE ORIENTATION OF THE SEISMIC PROFILES WITH RESPECT TO THE EAST-WEST COUNTY ROAD AND NORTH-SOUTH K-14 ARE SHOWN.

The isotime map (fig. 18) shows the present bed thickness of the Hutchinson salt under the surface expression at the sink. The time interval between the 20 msec and 35 msec contours represents about 30 m (100 ft) of depth change of the salt layer forming the basin-type feature.

The present surface subsidence does not account for all the apparent subsurface dissolution of the Hutchinson salt under the Janssen sink. Comparing fig. 18 with the present surface depression, the salt shows a disturbed area more than 10 times that present at the surface. The volume and extent of the surface expression of the sink does not match the estimates of the volume of salt dissolution. This implies that some material lying between the Hutchinson salt and the surface is bridged in a way that is supporting the weight of overlying strata. Release of this stress is likely. The mecha-

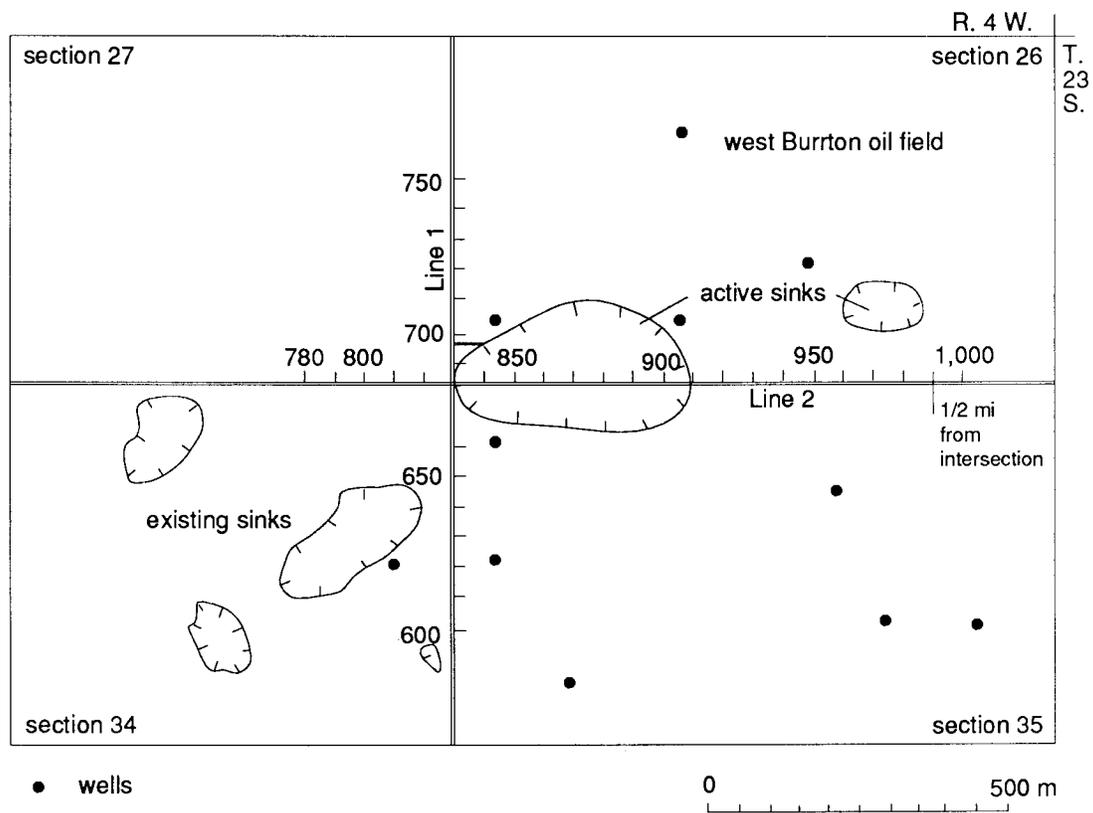
FIGURE 19—CDP-NUMBER LOCATION MAP OF PUNKIN CENTER SINK SEISMIC PROFILES IN RENO COUNTY. CDP interval is 5 m (17 ft).

To ascertain the likely fate of the road, the Kansas Geological Survey was contracted by Reno County to do a seismic-reflection survey between August 8 and August 10, 1983. Two profiles were run intersecting at 90° on the western boundary of the surface depression (fig. 19). Profile 1 runs north-south and profile 2 runs east-west just south of the center of the sink. Surface conditions were adequate for reflection profiling except near the center of profile 2 where it crosses the sink. Over the sink, road-shoulder conditions were poor and geophone plants and source operations were hampered. This resulted in a reduction in the signal-to-noise ratio from CDP 845 to CDP 904.
