Seismic-reflection surveys at sinkholes in central Kansas

by *Ralph W. Knapp, Don W. Steeples, Richard D. Miller, and Carl D. McElwee*
Kansas Geological Survey, Lawrence, Kansas 66046

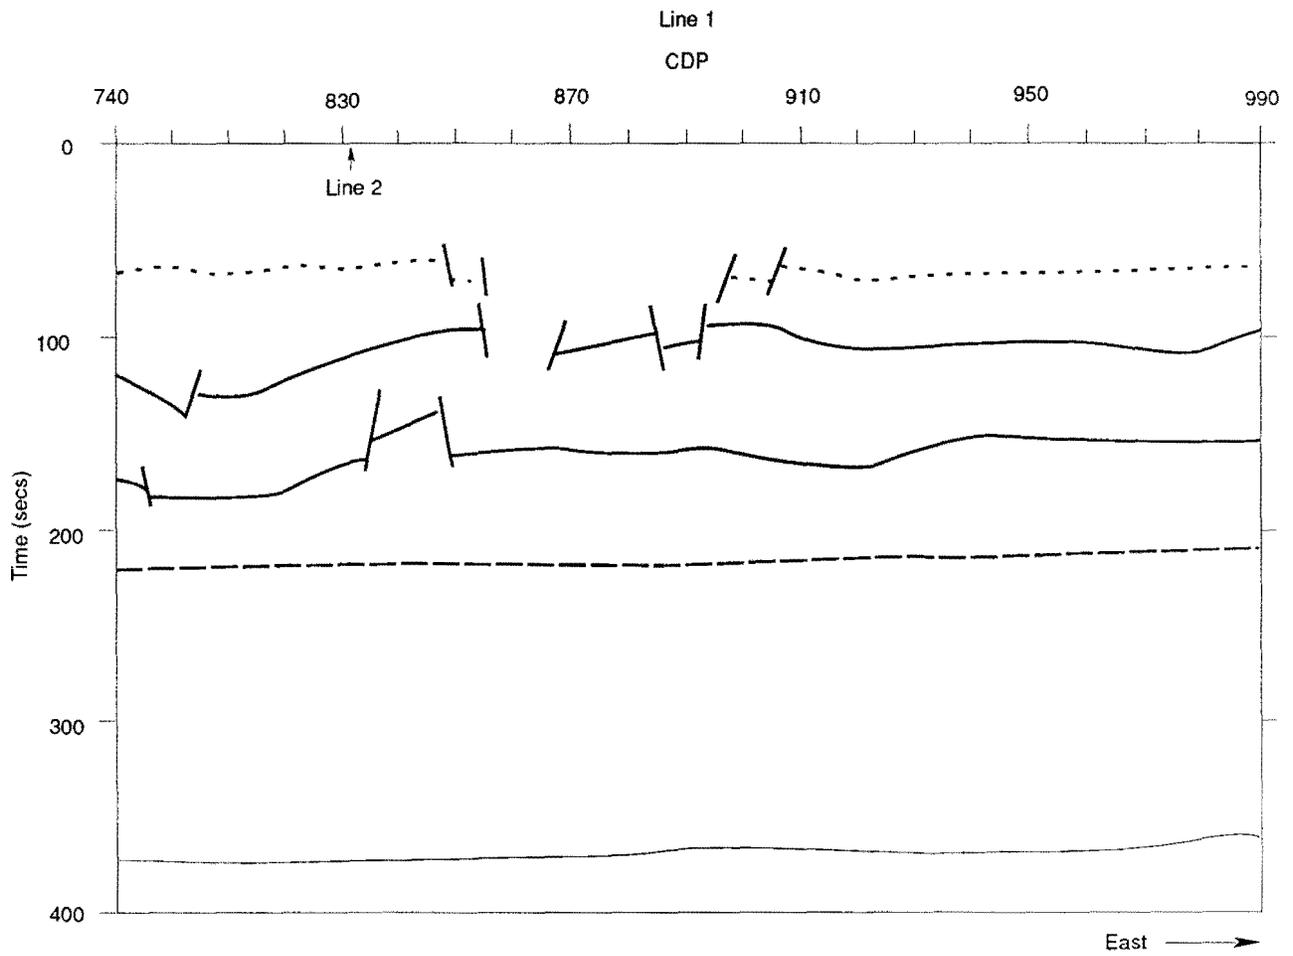
FIGURE 20—INTERPRETED SECTION OF PROFILE 1.

Intermediate layers of both profiles (figs. 20 and 21) show discrete layer offsets that could represent normal faulting. Such grabens also were observed on the I-70 data. Some evidence of faulting in the layers above the active dissolution zone is present. The layer offsets could also represent draping rather than actual faulting in the subsurface. We have not explicitly shown faults in our interpretation, but if faulting is present, it occurs where noticeable vertical offsets of layers are present within small horizontal distances. Both profiles suggest the presence of some pre-Pleistocene dissolution of the Hutchinson salt.

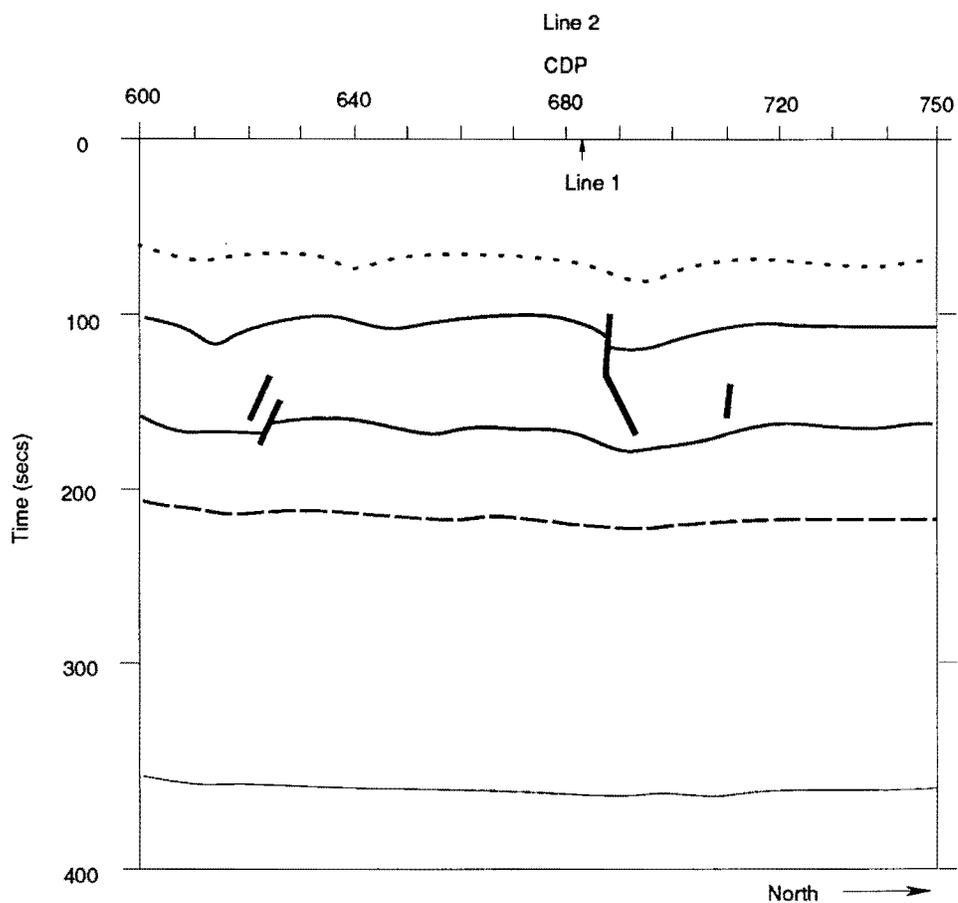
FIGURE 21—INTERPRETED SECTION OF PROFILE 2.

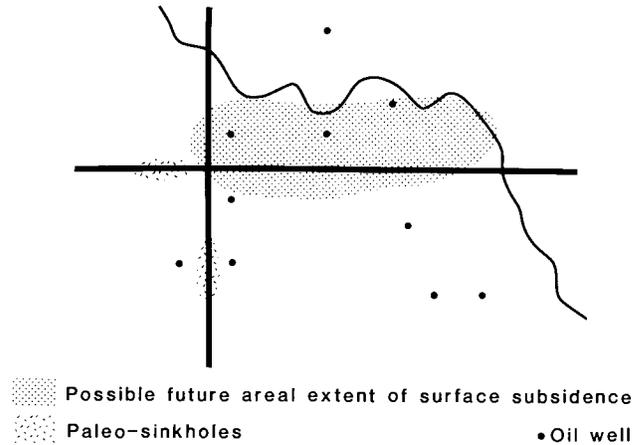
FIGURE 22 (RIGHT)—MAP OUTLINING THE LOCATION OF CURRENT SINKHOLES, PALEO-SINKHOLES, AND ULTIMATE ZONE OF SUBSIDENCE SUGGESTED BY SEISMIC DATA.

Assuming the paleosinkhole discussed above to be the result of total dissolution of the salt member, about 35 m (120 ft) of salt existed originally at the site. A crude calculation from seismic records suggests approximately 10 m (30 ft) of salt has been dissolved at the presently active sink. This means that about 25 m (80 ft) of salt could still be present. With 10 m (30 ft) of salt dissolution resulting in 3 m (10 ft) of surface slumping, 25 m (80 ft) more subsurface subsidence could result in as much as 8 m (25 ft) more surface sinking. If the rate of dissolution stays consistent, this gradual surface sinking could continue for several years. Speculation on the ultimate zone of influence of the sink is shown in fig. 22.
