CASE REPORT

Posterior Tibial Polyethylene Fracture in Cruciate-Retaining Total Knee Arthroplasty

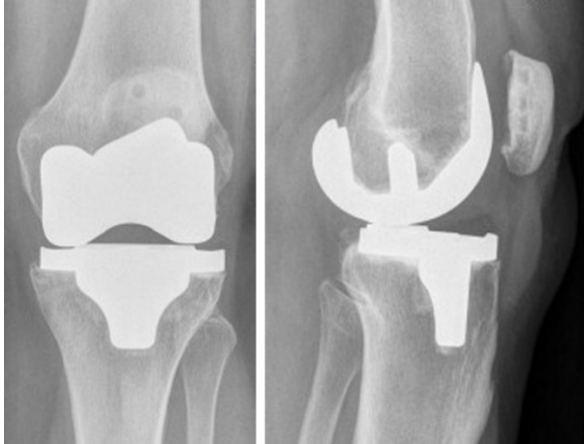
Three radiographs of the left knee were taken (anteroposterior, lateral, and sunrise). The results showed a CR knee without any sign of prostheses loosening. Anterior translation of the tibia was noticed (Figure 1). Laboratory blood tests were negative for infection. Therefore, she was diagnosed with flexion instability status post left TKA, and the plan was for the patient to undergo revision knee arthroplasty. The medical record of the patient's initial surgery obtained from an outside hospital showed a size 2 Stryker Triathlon CR femoral component (Stryker, Mahwah, NJ), and a size 2 Triathlon tibial baseplate with a 9 mm thickness of X3 CR tibial polyethylene insert.

Figure 1. Anteroposterior and lateral radiographs of left knee show evidence of instability with anterior subluxation of tibia.

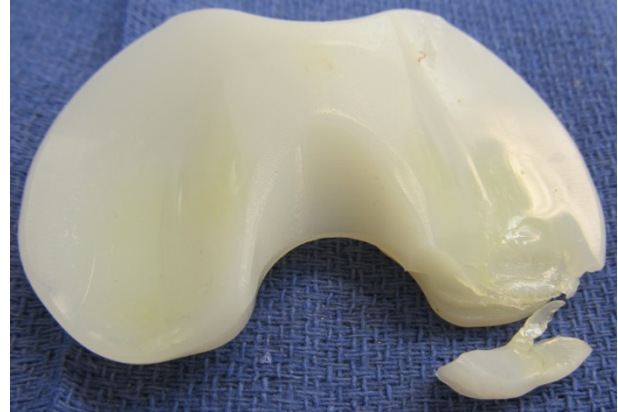
During the surgery, after the medial parapatellar arthrotomy and synovectomy were performed, a loose fragment of polyethylene was noted in the lateral gutter. This measured 5 mm X 15 mm (Figure 2). Subsequently, the polyethylene insert was removed. A fracture was seen at the posteromedial aspect of the polyethylene insert with severe wear posterolaterally (Figure 2). The femoral component was revised to a size 3 Stryker Triathlon total stabilizing femoral component with 12 mm x 50 mm cemented stem and 5 mm posterior augments both medially and laterally (Figure 3). A 9 mm thickness polyethylene tibial insert also was used to restore the joint line. The tibial component was retained. Intraoperative exam showed excellent range of motion and stability in both flexion and extension.

Figure 2. Polyethylene insert with significant posterior wear and posteromedial fracture.

In this case, the primary causes of accelerated posterior wear and fracture of the polyethylene tibial insert was suspected to be the improper balance of the soft tissues. To have an excellent outcome with CR TKA, the surgeon must appreciate the importance of proper PCL tensioning. A loose or lax PCL may defeat the purpose of the design as the knee may have instability with anterior and posterior displacement when the PCL is too loose.⁴ Along with a flat design and little inbuilt constrain of CR polyethylene insert, anteroposterior instability can allow the femoral component to slide and rotate excessively on the tibia surface. This may increase the shear force and accelerate the polyethylene wear, leading to down sloping of the polyethylene surface. It further accentuates the tibiofemoral subluxation, surface degradation, and subsequent component failure. Alternatively, excessive tensioning of the PCL may lead to excessive femoral rollback. This may lead to increased translation of the articulation posteriorly, thus producing high stress and even increased wear on the posterior polyethylene insert.

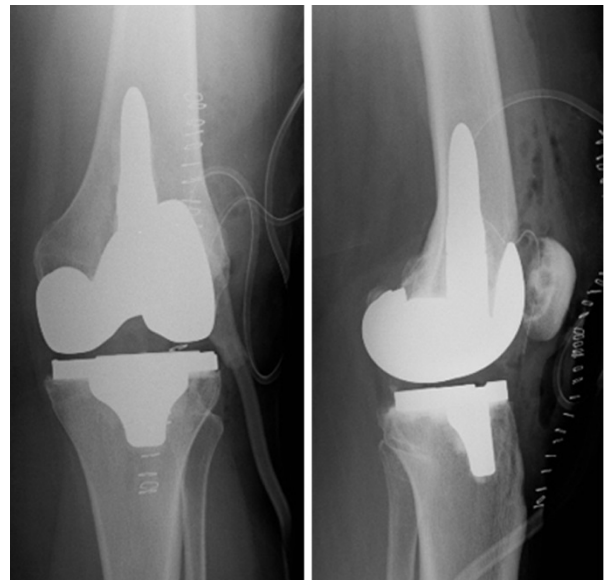
Figure 3. Immediate post-op anteroposterior and lateral radiographs following the revision of the left TKA.
