FLOWAGE IN ROCK SALT AT LYONS, KANSAS

> By LOUIS F. DELLWIG

State Geological Survey of Kansas, Bulletin 130, Part 4

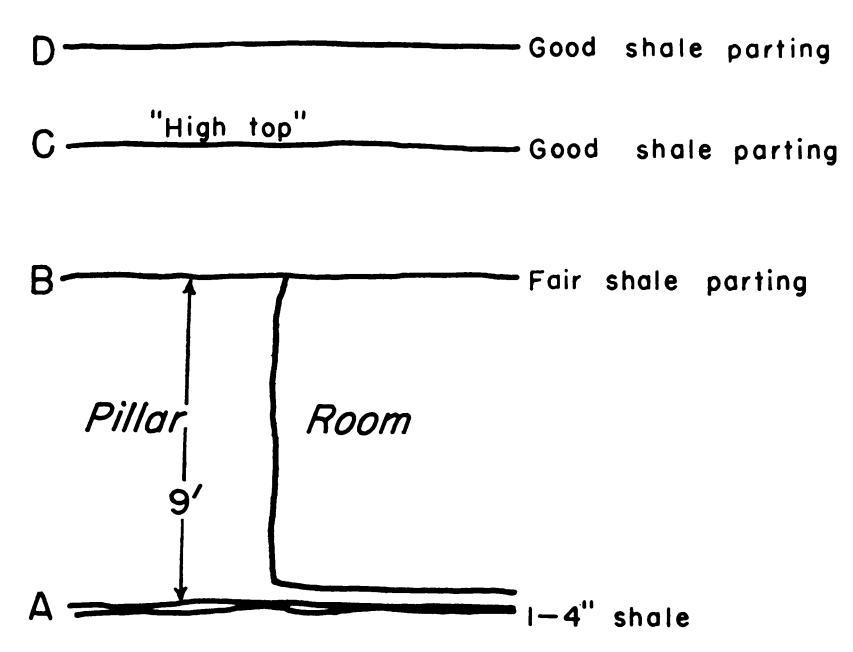
FIG. 1.—Sketch of mine section. Mining between A and B has resulted in no roof fall. Mining in the past to C (high top) has resulted in downbuckling and collapse of the layer between C and D.

Thick layers of clay determine the vertical limits of mining (Fig. 1). The mine floor is cut as close as practicable to a 1- to 4-inch shale bed; only enough salt (generally less than 1 foot) is left to prevent breakthrough to the shale, which would contaminate the mined salt. Blasting to a shale parting 9 feet higher produces a smooth break at the roof, and a tight roof. At approximately 44 inches and 78 inches above the roof are two additional pronounced partings, the lower of which is called the "high top". Mining to the "high top" results in a weak roof, characterized by numerous falls of the overlying 36 inches of rock. Mining to the parting 36 inches above the "high top" cannot be considered, because of the impurity of the salt in that section.

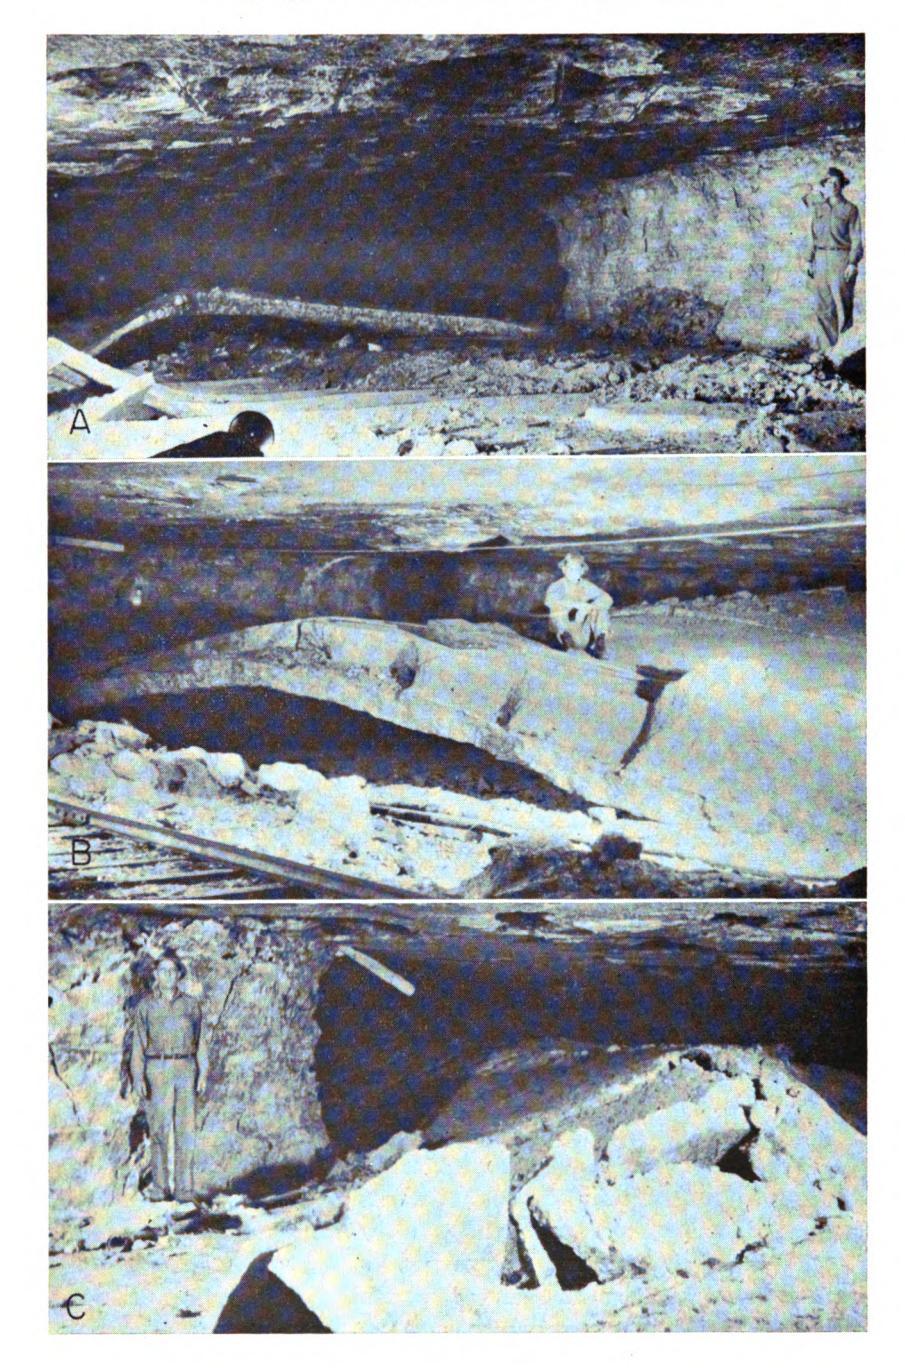
PLATE 1—A. Floor buckles in thin salt layer, showing variations in location and orientation of axes. B. Floor buckles along main haulageway. Room is 48 feet wide and 6.3 feet from original position of floor to roof. At open end of fold 2-foot salt layer has risen 3.2 feet. In rear of room, salt layer has buckled to touch roof. (Camera facing west.) C. Continuation of fold shown in **B**. In this room only a thin layer of salt was left in floor. (Camera facing south.)

The floor of the Lyons mine is characterized by buckles and by shear and tension fractures. Buckling is reported to begin within one week after the opening of some rooms. These "folds" may form only a small arch on one side of the room (P1. 1A) or may extend completely across the room, the crest of the fold reaching almost to the roof of the room (P1. 1B). They generally extend only from crosscut to crosscut in a room or from room to room in a crosscut, but a few have been traced through two

crosscuts or rooms, and some folds make a right-angle bend from a room to the adjacent crosscut (Pl. 1B,C). The folds involve only the salt layer above the shale parting and thus are variable in thickness. Many are fractured at the crest and at the junction of arch and floor. (Pl. 2A). In many areas of the mine, welldeveloped arches have sufficient strength to resist collapse despite constant operation of a shuttle car or railroad over the crest. Some arches have continued to rise even after the installation of track and the operation of the train in the main haulageway.

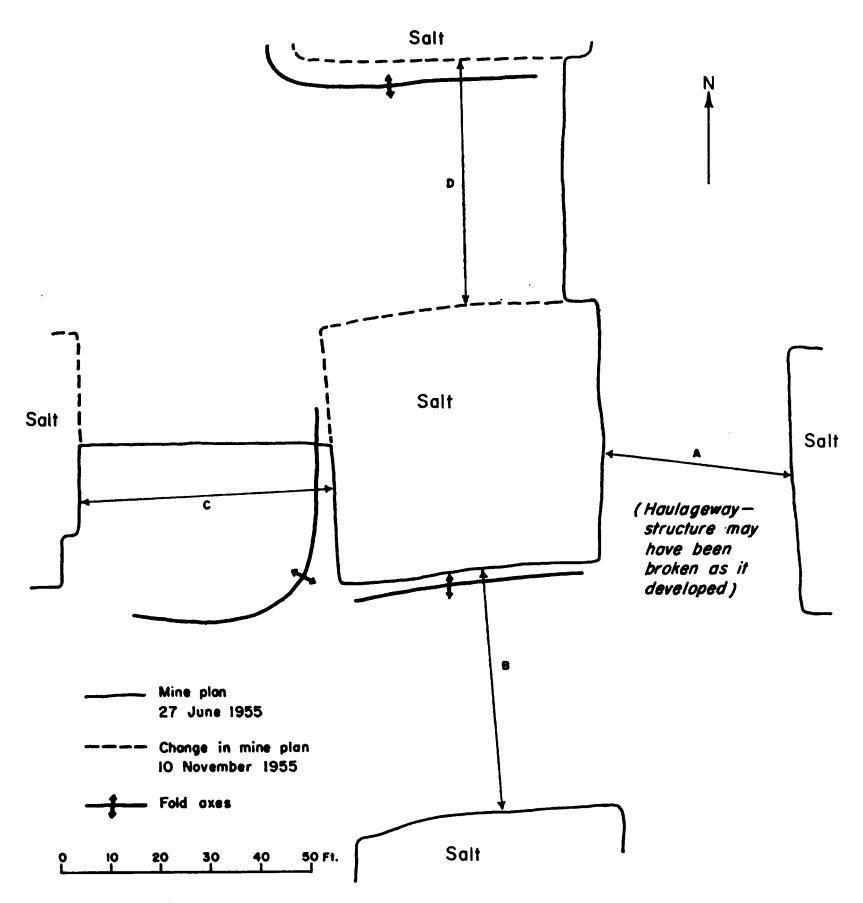
FIG. 2.—Sketch of mine plan in study area.

cuts); and (3) differences in thickness of the salt layer left above the shale parting in the floor. As a result, measurements were made only between points directly across a room or crosscut approximately half way up the pillars and half way from the corners (Fig. 2). The location of the points was determined by the solidity of the wall. So that early spalling might not affect measurements, wood plugs were set several inches back from the face in holes drilled in the pillars. Pins were driven into the plugs until they were in contact with the salt in the end of the hole. The study was terminated when spalling moved the plugs and pins.

TABLE 1—Measurements, in feet, between pillars along lines shown in Figure 2

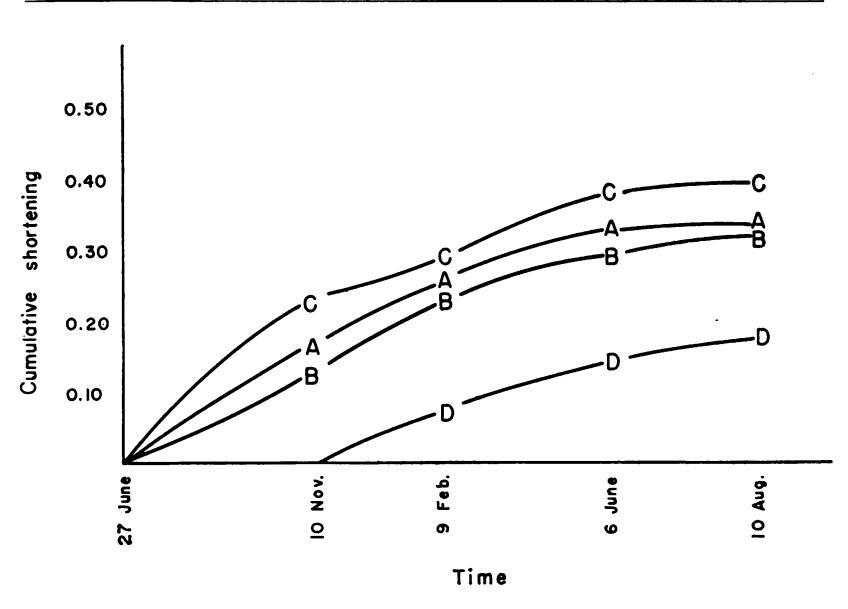
FIG. 3.—Curves showing cumulative decrease in measurements along lines A, B, C, and D between pillars.

Plastic flow of salt within the pillars is indicated by measurable decrease in width of room and crosscut during the period of observation (Fig. 3). In general there has been a decrease in the rate of flowage and, although accurate measurements can no longer be made, it is to be noted that with the decrease in rate of flowage, spalling becomes more common. Thirteen months after the last measurements were taken, continued movement was indicated by further accentuation of earlier formed folds, by opening of new fractures in the floor, and by enlargement of previously developed fractures.
